Space Shuttle Orbiter Corrosion History, 1981-1993

A Review and Analysis of Issues Involving Structures and Subsystems

NASA Technical Memorandum 104810

**A report of the
Orbiter Corrosion Control Review Board**

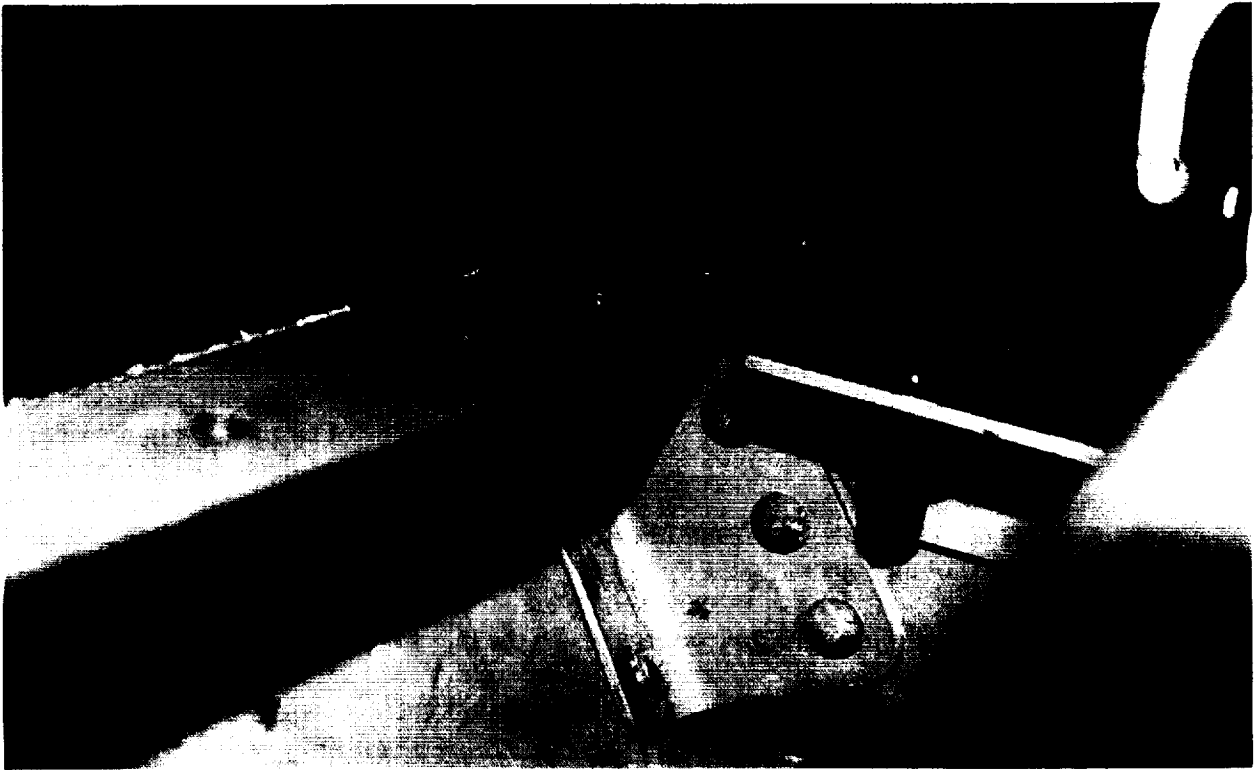
- d. Body Flap Cove. Corrosion was recently discovered in the body flap cove of OV-103, shown in figure 8. Two areas of corrosion were noted: (1) rivets in the cove area and (2) at the actuator fitting to airframe faying surfaces. Corrosion of the rivets has been attributed to a galvanic couple between the aluminum rivets and titanium actuator fittings. Structural analysis indicated that the need for the rivets was minimal. The rivets are not replaced until 30% of the exposed head is missing. The actuator fitting corrosion was pitting. These areas were all cleaned and re-Koroponed. Mold impressions revealed defect dimensions 0.623 inches long, 0.195 inches wide and 0.023 inches deep; the fitting in this area is 0.080 inches thick. These items are currently under review by the CCRB.

Figure 8. Corrosion found on the body flap cove structure from OV-103.
